Staff Report

Historic Review for Use of Substitute Materials

Siding and Windows

HI-05-20

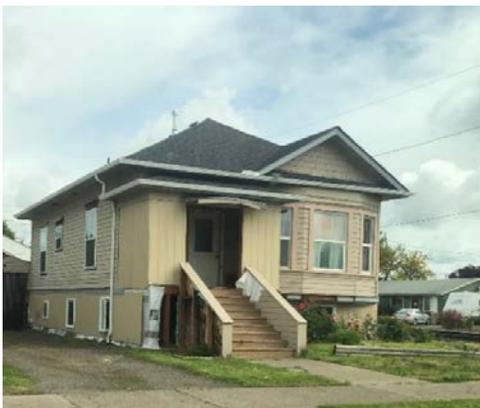
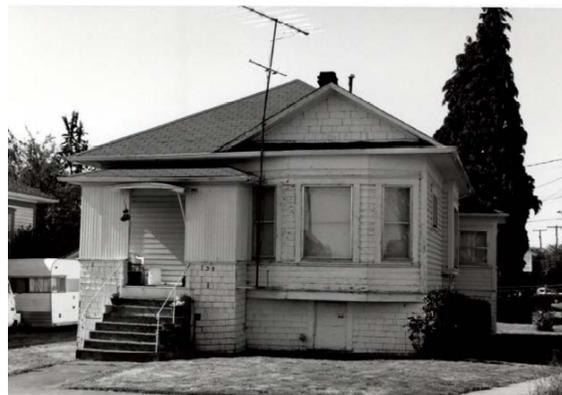
Image 1: Window type comparison

- 1.2 Existing Window Condition. The historic resource survey identifies one-over-one double-hung windows as the primary window type. Street view data from 2018 indicates that some of the original windows had been replaced under previous ownership. The applicant has replaced all the existing windows with what appear to be single-hung vinyl windows. The placement of the windows has not been altered. Also, the size, scale, and openings appear to be approximately the same. A window may have been added to the basement of the front façade where the historic resources survey shows there was previously a covering.

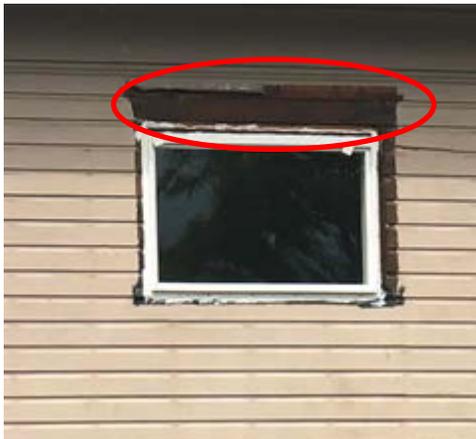
- 1.4 Existing Window Trim Condition. The applicant has indicated that the existing trim around the exterior of the windows was rotted and not salvageable (Attachment D.3). On some portions of the house where trim has been removed, there appear to be some signs of water damage. All the original window trim has been removed.

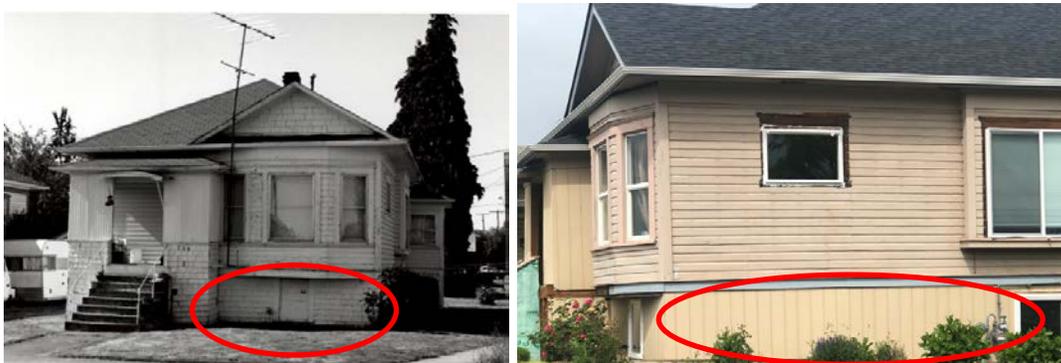
- 1.5 Window Trim Costs. The application submittal includes an estimate showing the cost difference between replacing the existing trim with like materials and using brick mould with primed Wolmanized fascia (see Attachment D.6 & D.7). The provided estimate indicates that new trim using original materials would be \$741.32 and replacing the trim using updated materials would be \$655.
- 1.6 Existing Basement Siding. The original siding identified in the historic resources survey was wood shake shingles. The existing siding appears to be a composite plywood material. The applicant is proposing to replace the existing siding with Hardie straight shingle using composite material.

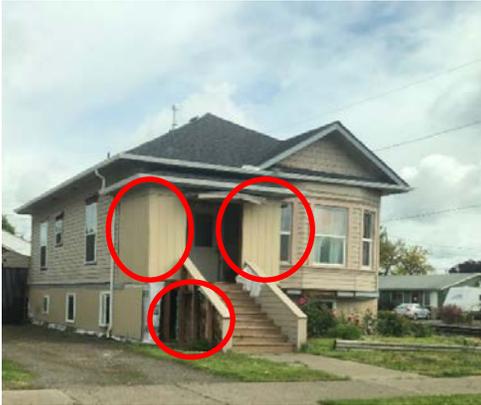
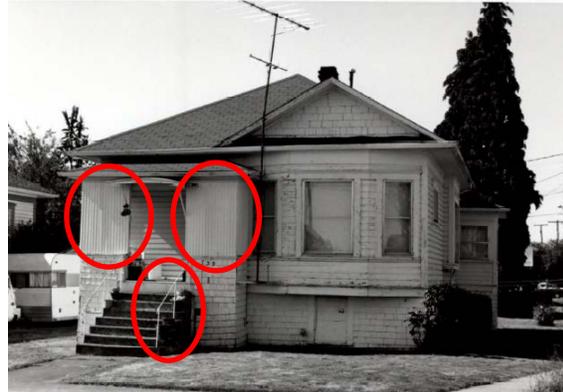
- 1.8 Existing Porch and Railing Siding. The siding materials used for the enclosed porch and railings on the front elevation of the structure appear to be the same composite plywood material used on the trim of the house. It should be noted that the existing siding along the railings has already been removed. The historic resources survey indicates that the porch enclosure and railings on the front elevation of the house were modified from the original structure. These modifications included wrapping the porch in corrugated plastic materials and an addition of metal hand railings to the stairs. The applicant is proposing to replace the existing siding around the enclosed porch and along the stair railing with Hardie lap siding.
