City of Albany Historic Review Application (File No. HI-07-20)
Property Address: 615 Fourth Avenue SW
Linn County Assessor's Map No. 11S-04W-12AA; Tax Lot 1600

Findings of Fact

PROPERTY & PROJECT INFORMATION

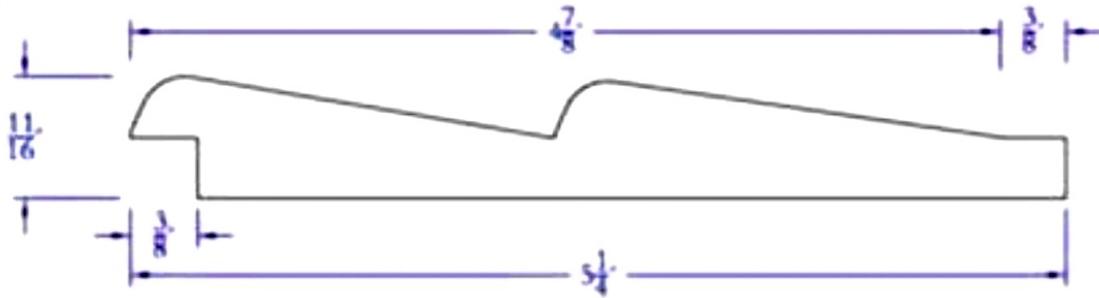
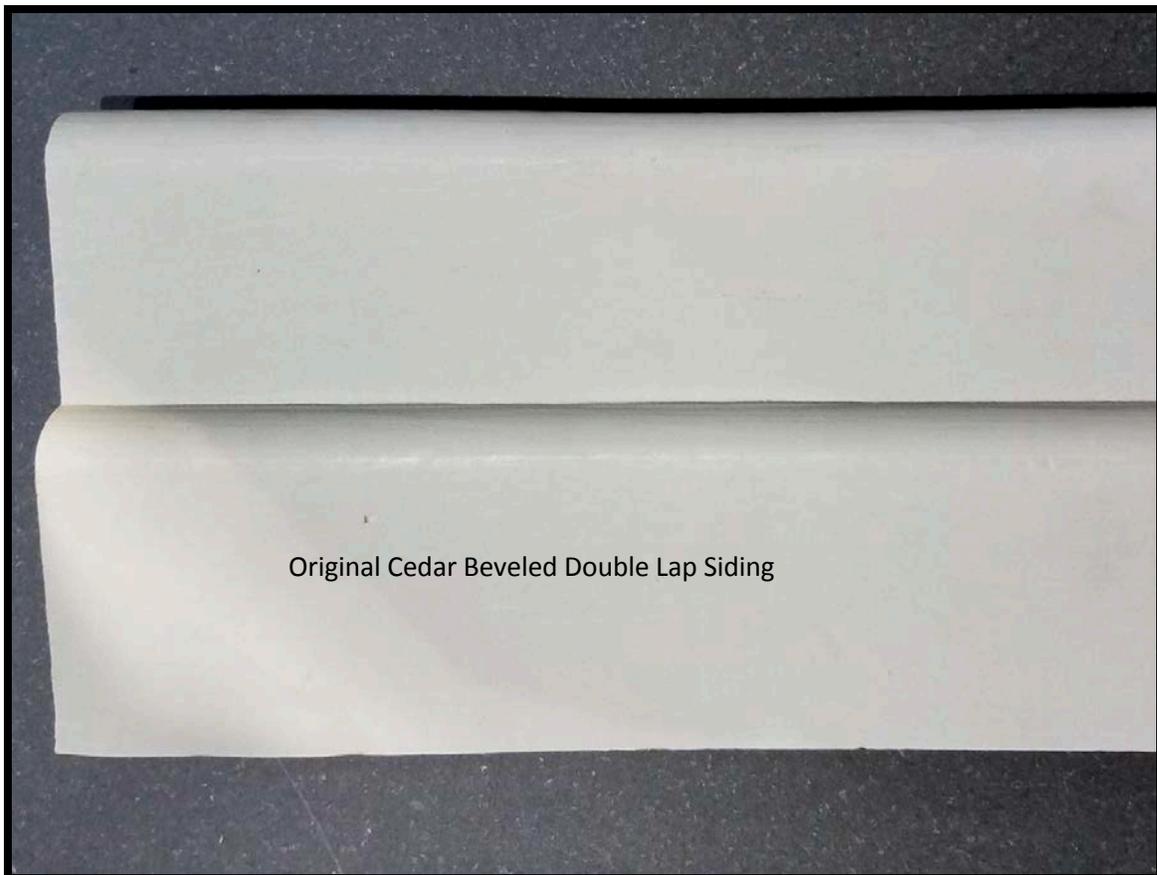
(1) *The Profile and dimensions of the matched ORIGINAL Wood (Beveled Double Lap Cedar) Siding*

Said original wood siding was Cedar Beveled Double Lap Siding, 5 ¼" wide x 11/16" thick. The size for the exterior trims around all doors and window were 5 ½" wide, coupled with crown moldings on top. The pictures listed below will show further details of the original installed siding and how we matched it accordingly. In the process, we wrapped all distorted railing posts with new wood, which all shall be painted, and replaced all dry-rotted spindles on the handrail with Cedar.

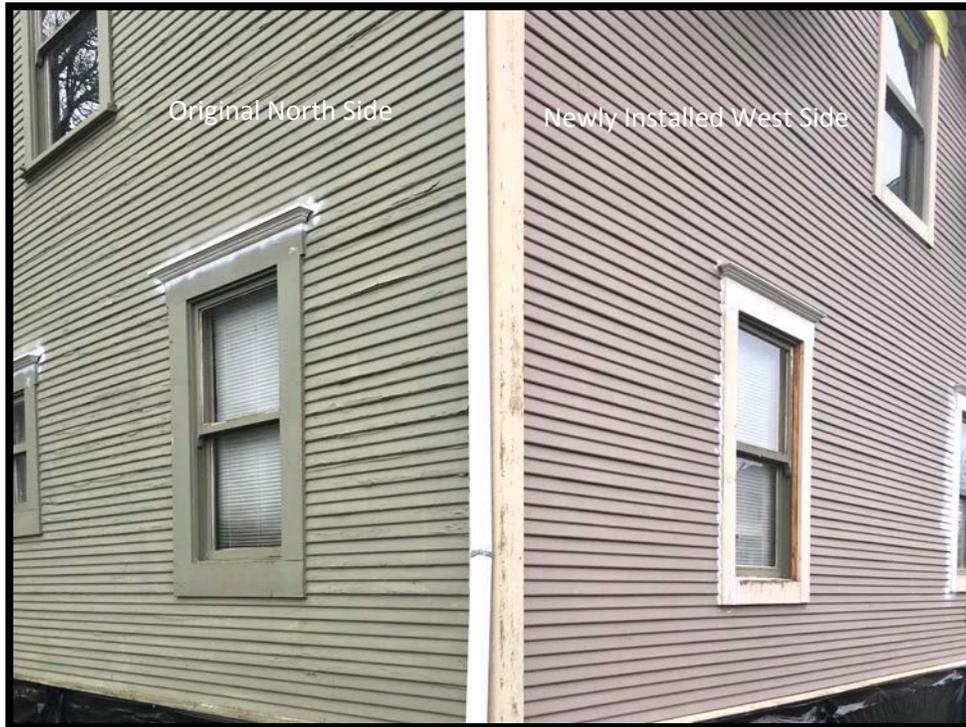
(2) The NORTH WEST Corner of the structure, showing the existing ORIGINAL siding (Left Side of Picture) and the NEWLY MATCHED siding (on the Right Side of Picture)

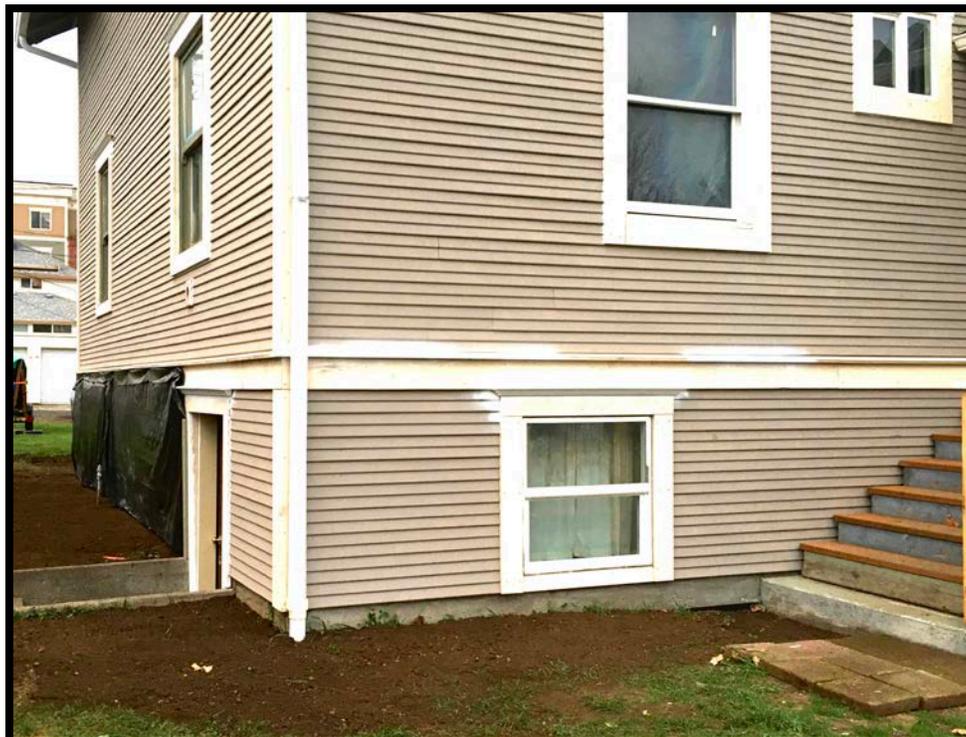
(3) The SOUTH WEST Corner of the structure showing the two newly installed Cedar Beveled Siding

Mitigating the damaged areas, we only needed to replace the siding of two sides of the property (South and West). The remaining two sides (North and East) were still in an acceptable shape. Furthermore, there were several areas covered with an inferior particle board, which seemed to be installed in recent years. Notwithstanding the inconsistency, other areas didn't have any siding at all, mainly bare plywood. Giving special attention to the historic details of the property, we proceeded to search for an IDENTICAL siding that matched the original old structure in design, color, texture, and other visual qualities. Moreover, we sought to remove all recently installed inferior particle boards and replace it with the new (original) beveled wood siding, thereby matching the rest of the structure.

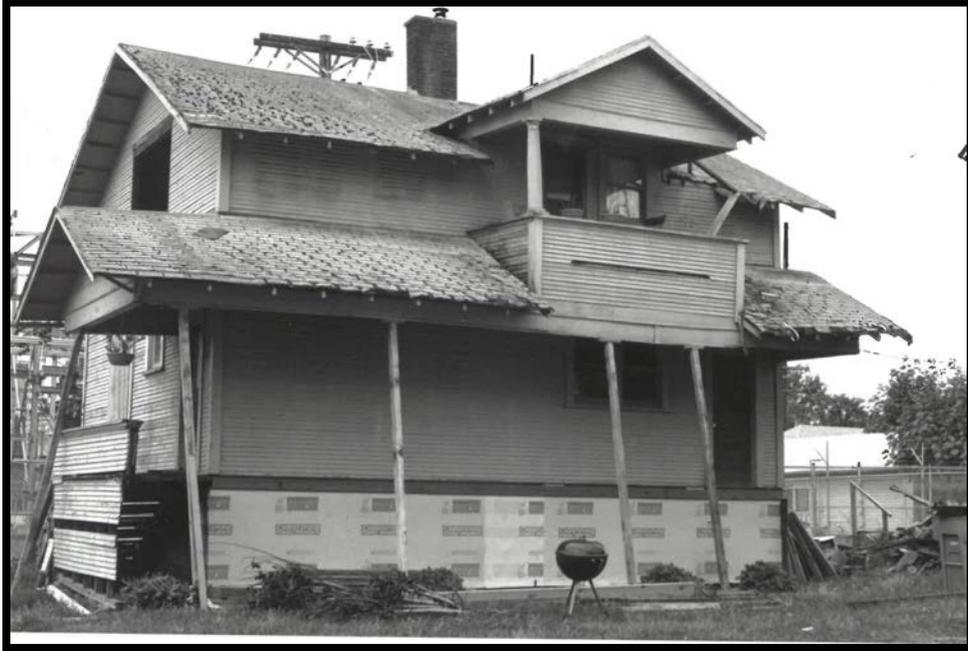
(4) The ORIGINAL SOUTH EAST Corner of the structure as shown in 1910

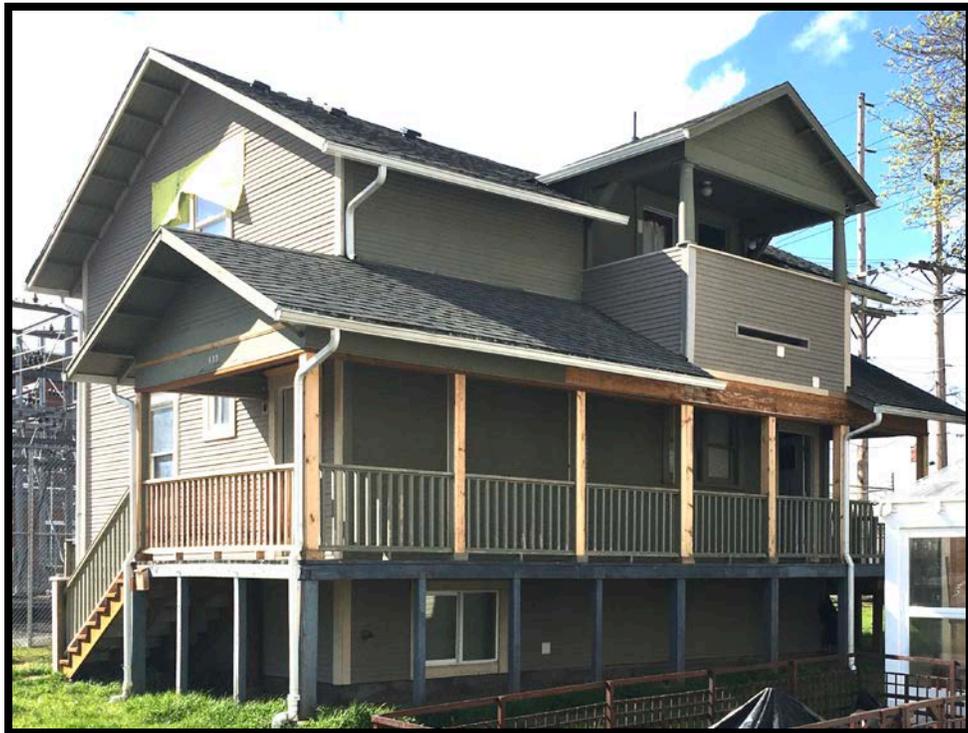
(5) The CURRENT SOUTH EAST Corner of the structure as shown at this time

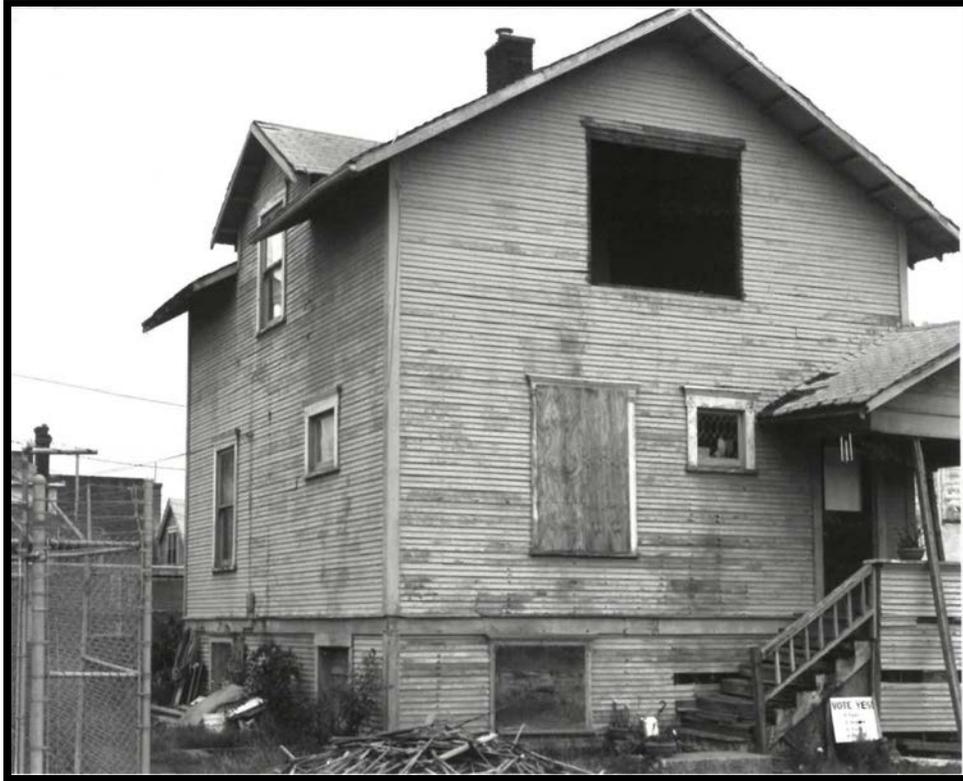
(6) *The ORIGINAL SOUTH WEST Corner of the structure as shown in 1910*

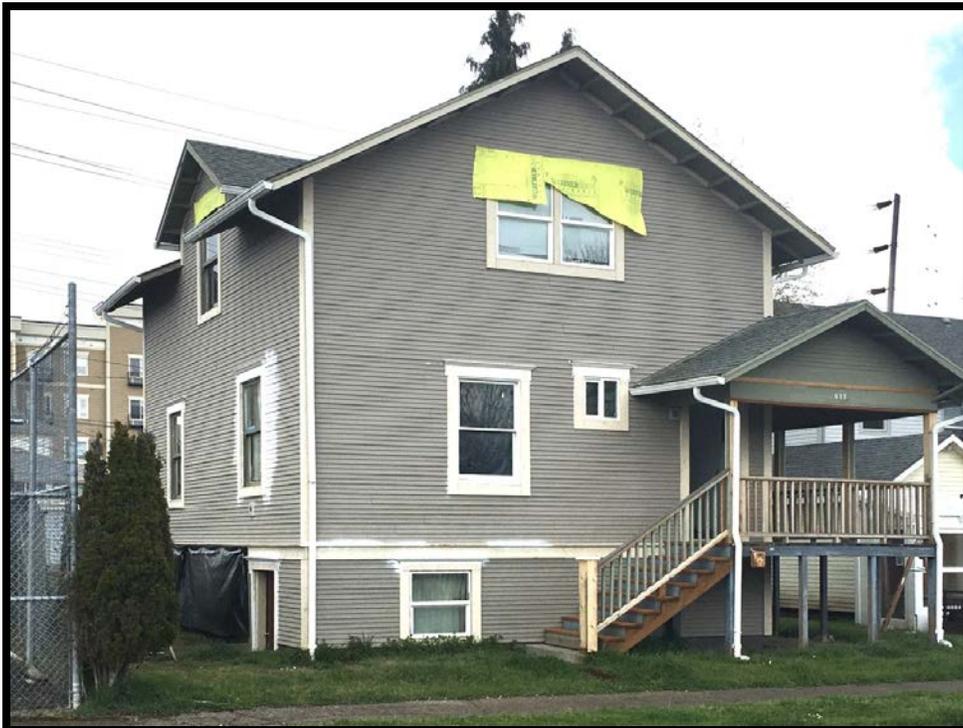
(7) *The CURRENT SOUTH WEST Corner of the structure as shown at this time*

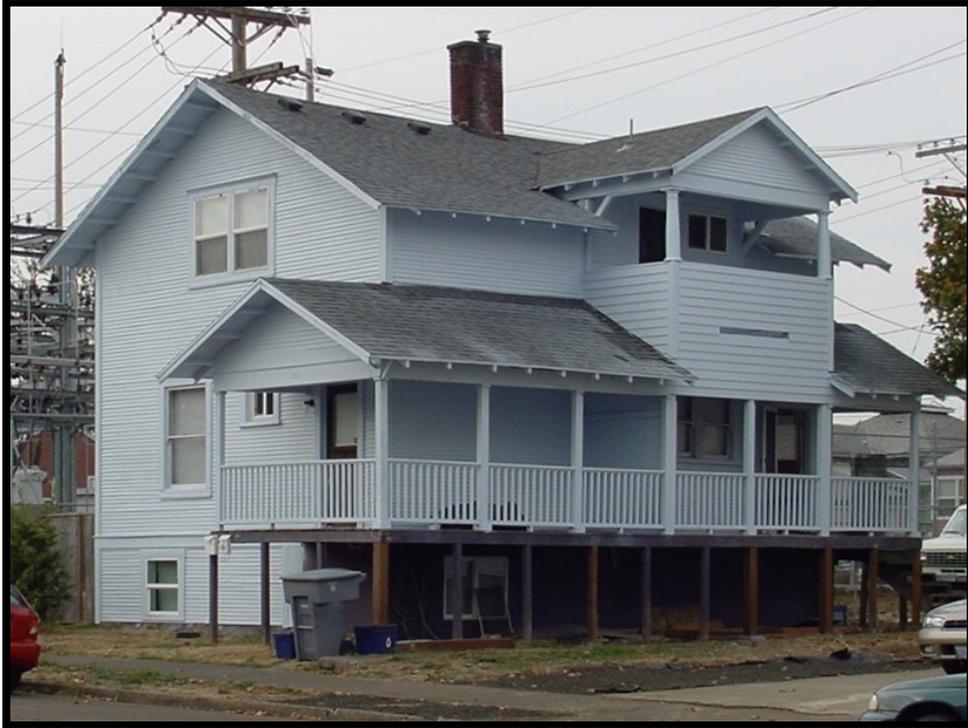
(8) The SOUTH EAST Corner of the structure as shown in 2006

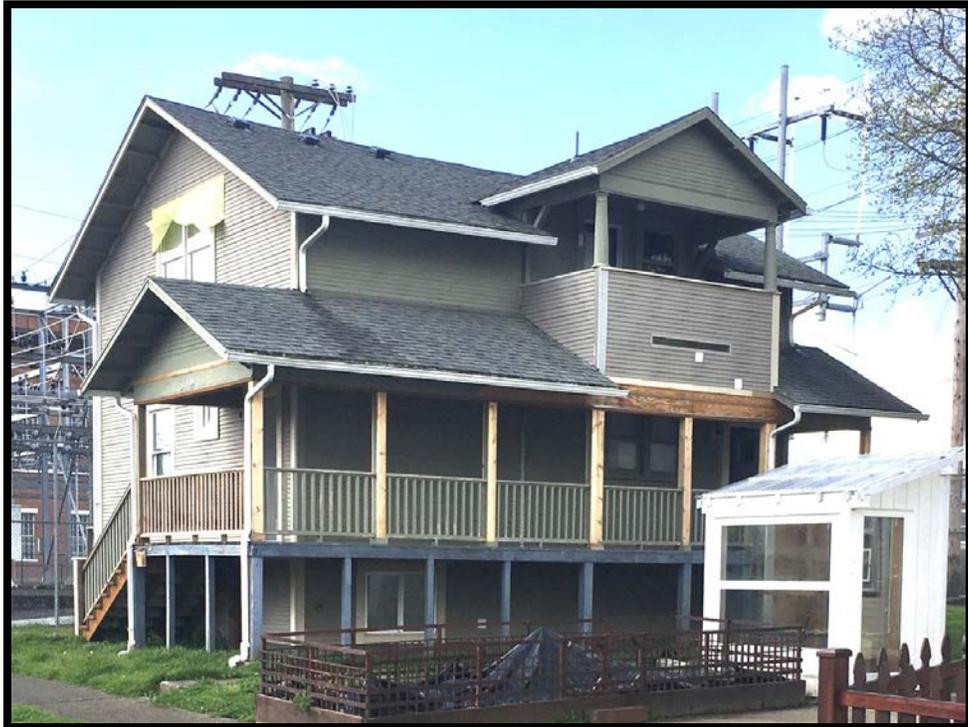
(9) The SOUTH EAST Corner of the structure as shown at this time with the new wrapped wood around the railing posts

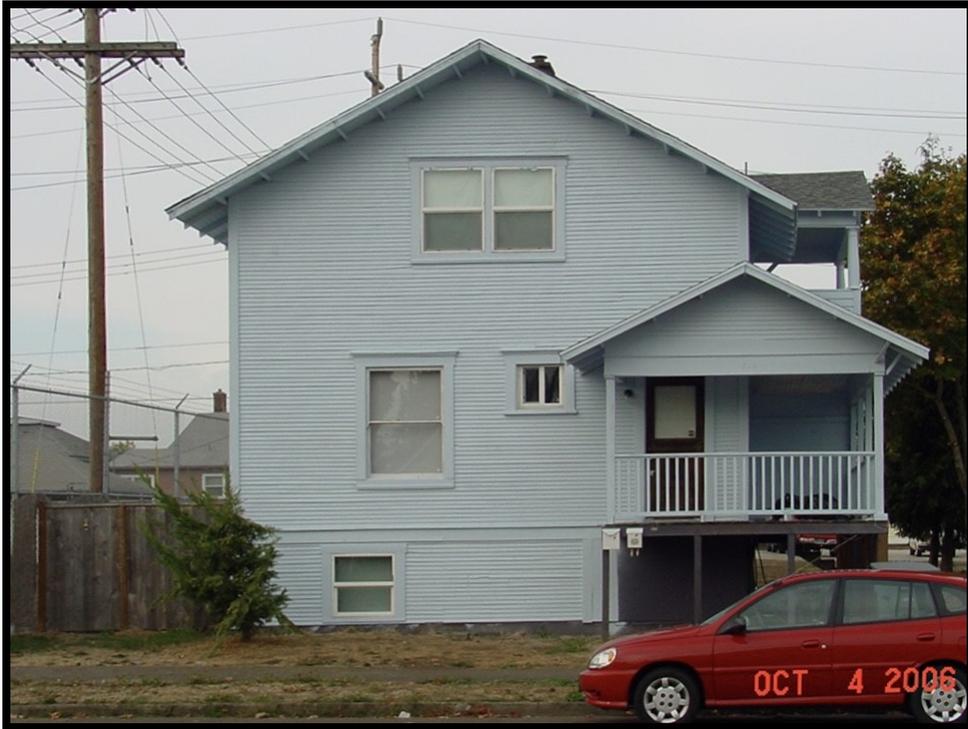
(10) The NORTH side of the structure as shown in 2006. NOTE how the front stairs were initially removed and then later added as shown in the ORIGINAL structure of 1910

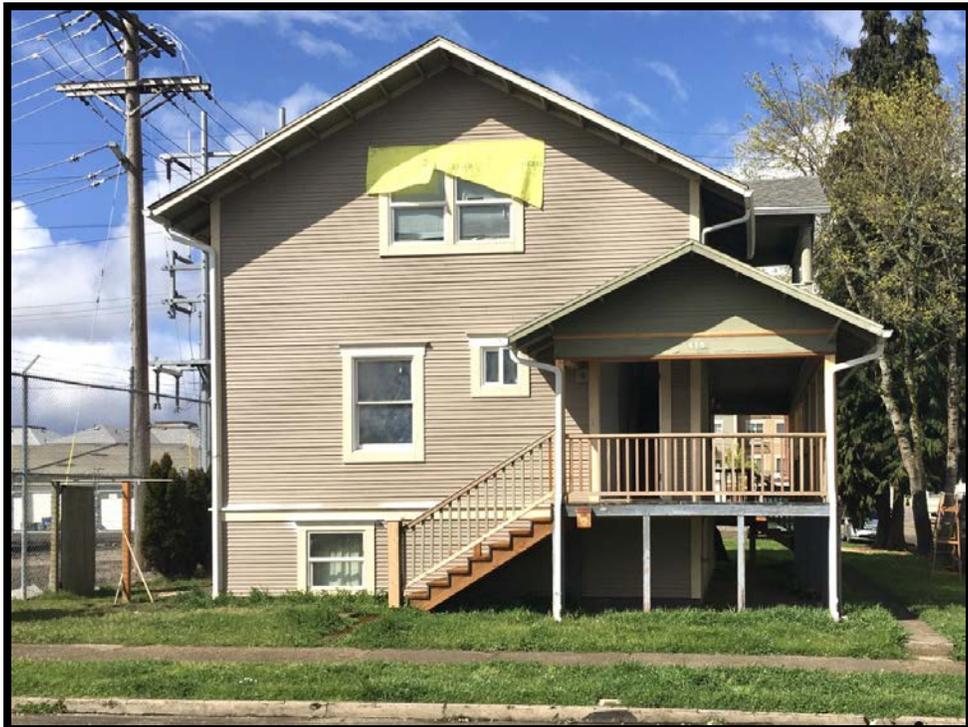
(11) The NORTH side of the structure as shown at this time

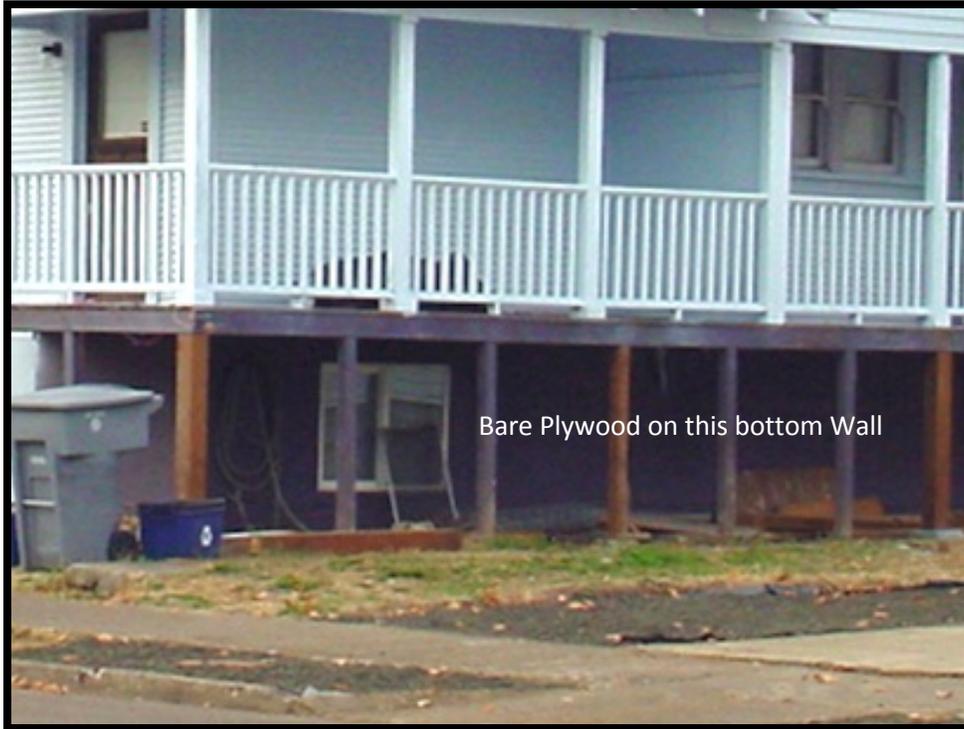
(12) The SOUTH EAST Corner of the structure showing the BARE PLYWOOD at the bottom wall in 2006

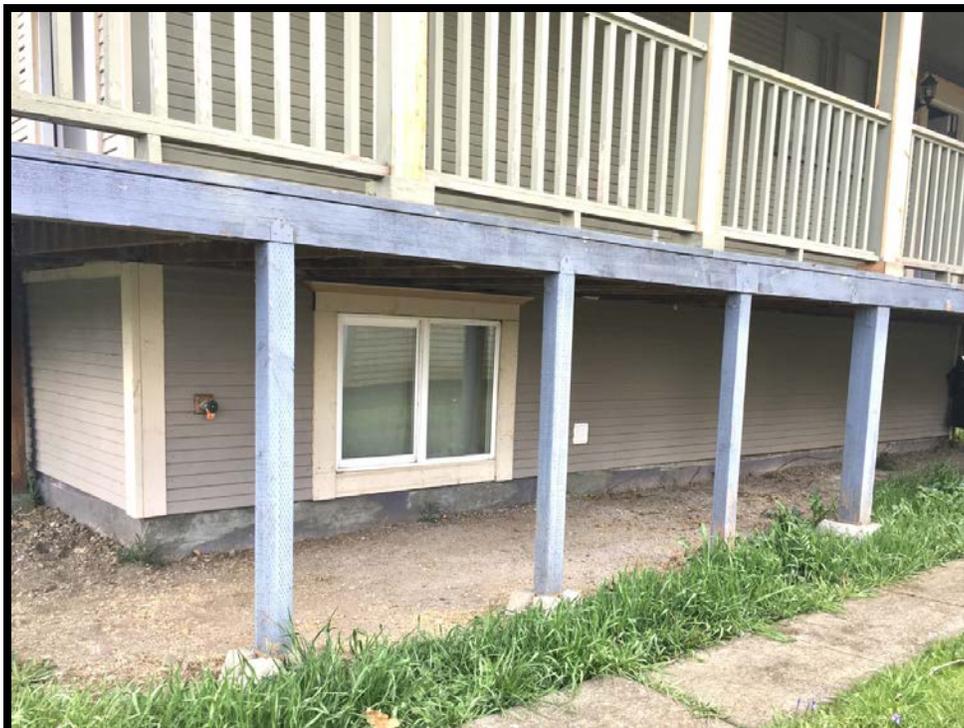
(13) The SOUTH EAST Corner of the structure with the NEWLY installed matching original Beveled Double Lap Cedar Siding as shown at this time

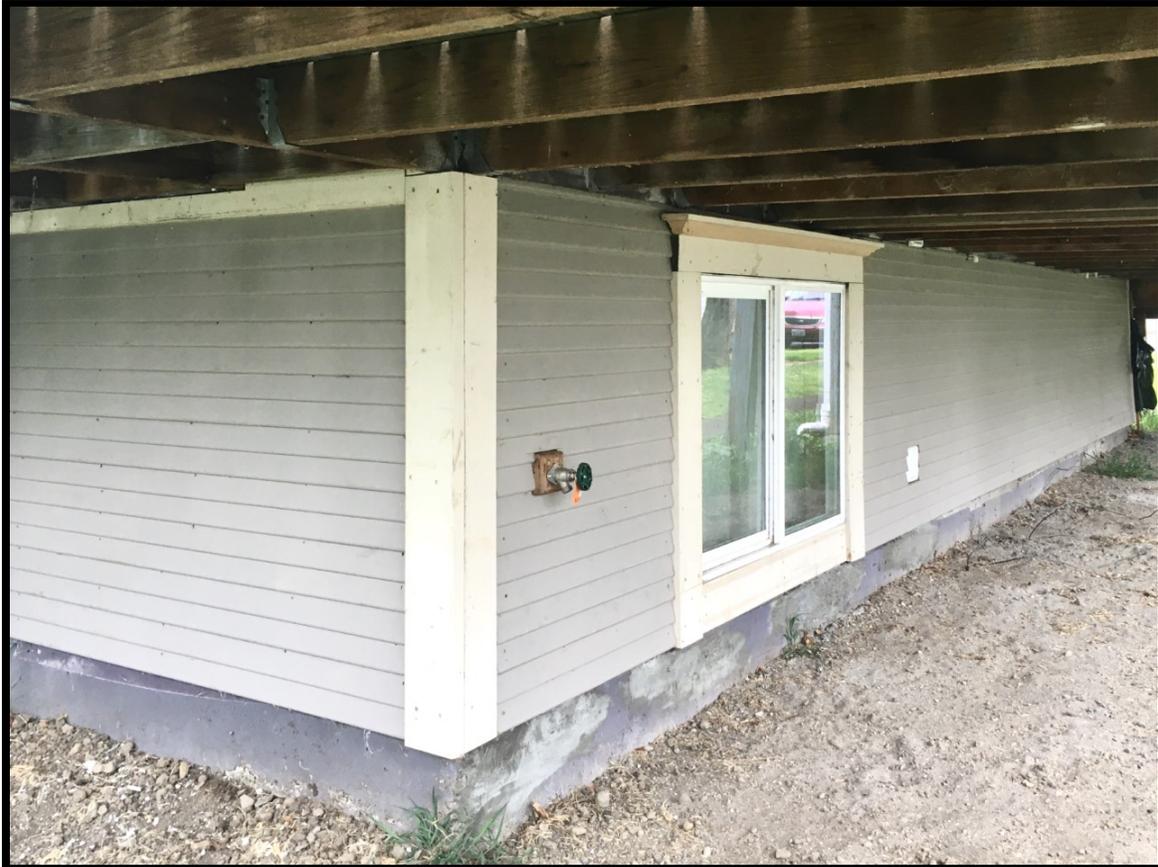
(14) A closer look of the SOUTH EAST Corner of the structure with the NEWLY installed matching original Beveled Double Lap Cedar Siding as shown at this time

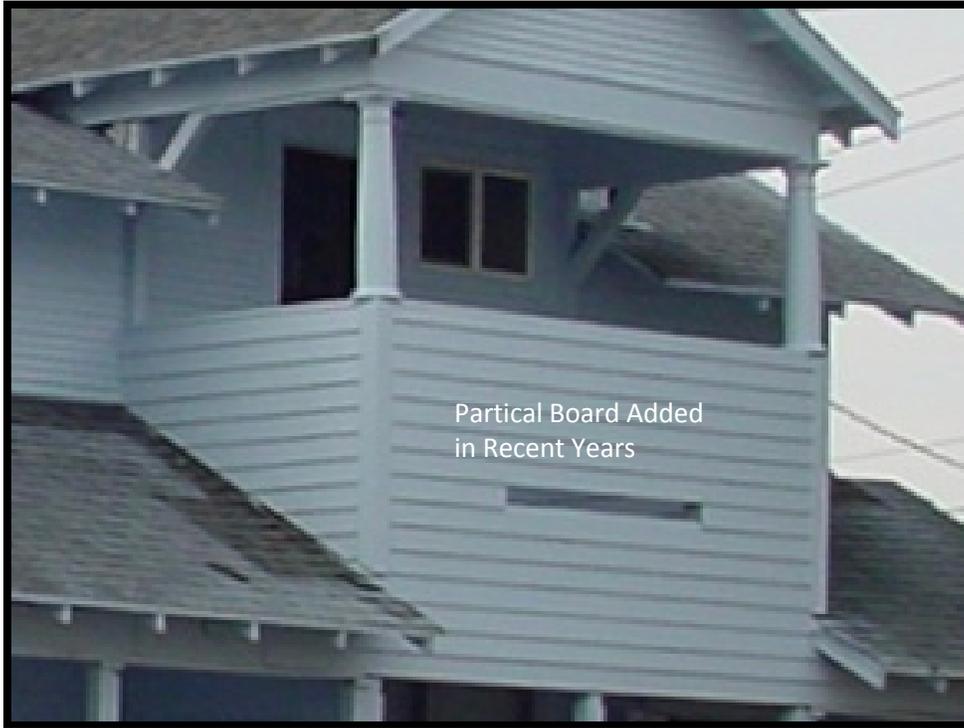
(15) The SIDING of the upper balcony consisted of INFERIOR PARTICLE BOARD in 2006

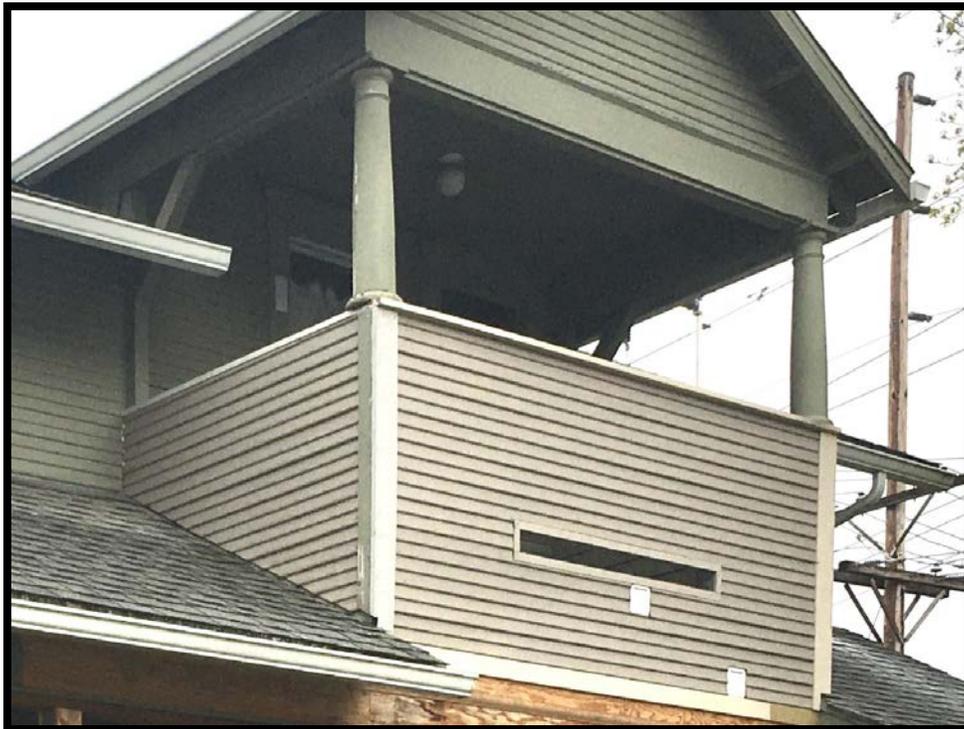
(16) The PARTICLE BOARD is now removed and replaced with NEW ORIGINALLY MATCHED Beveled Double Lap Cedar Siding as shown at this time

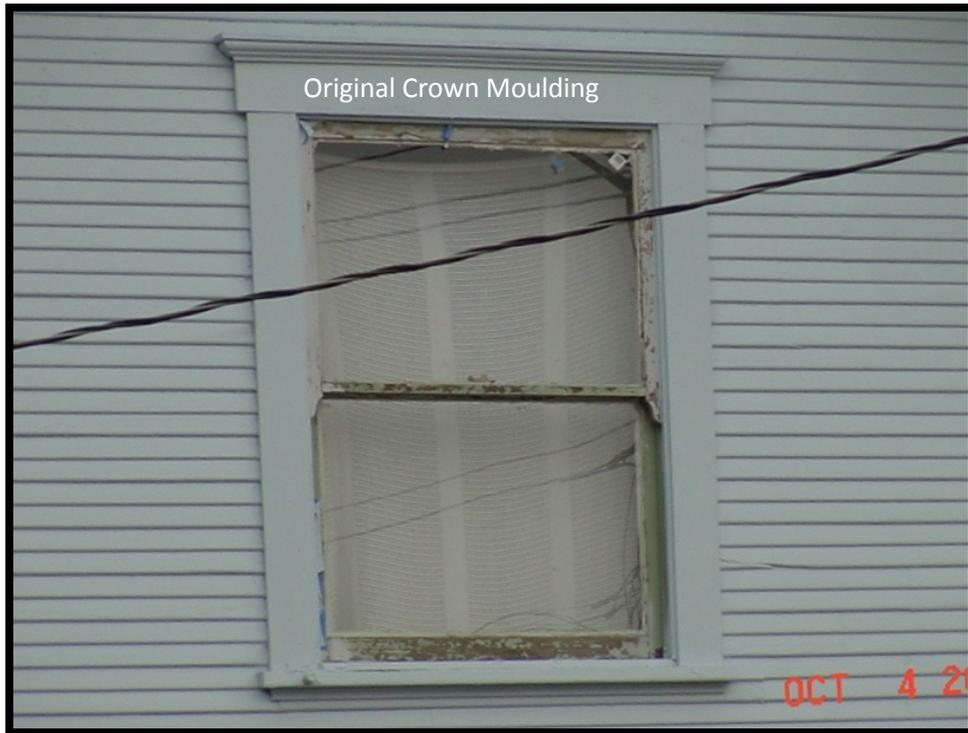
(17) The TRIM and CROWN MOLDING'S detail of the ORIGINAL Window on the NORTH side

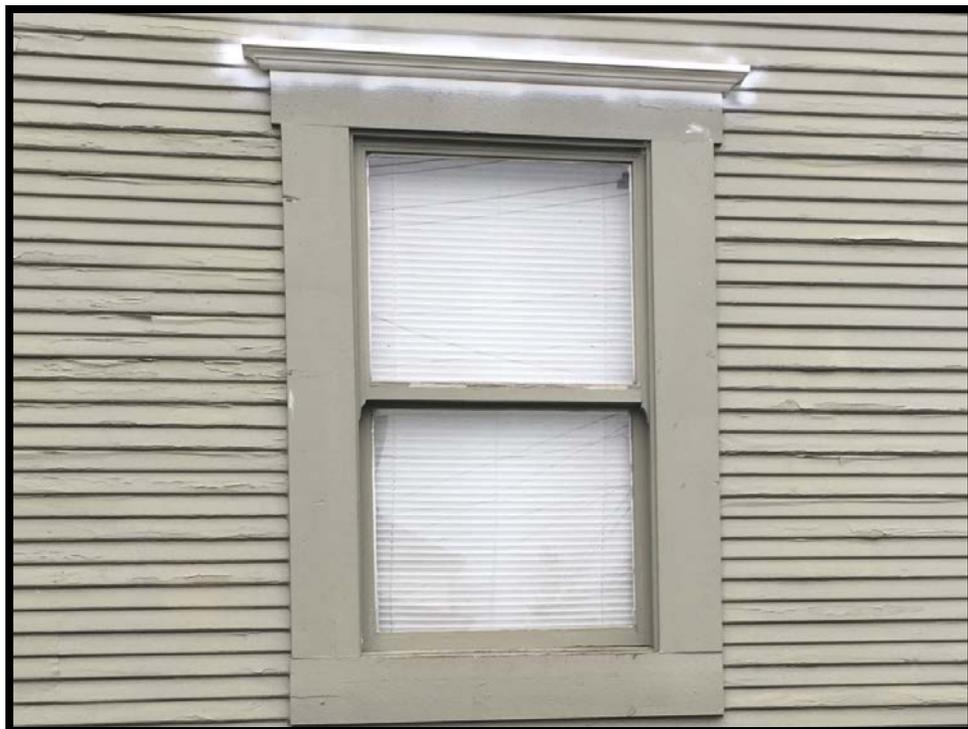
(18) The TRIM and CROWN MOLDING closely matching the ORIGINAL Structure of 1910

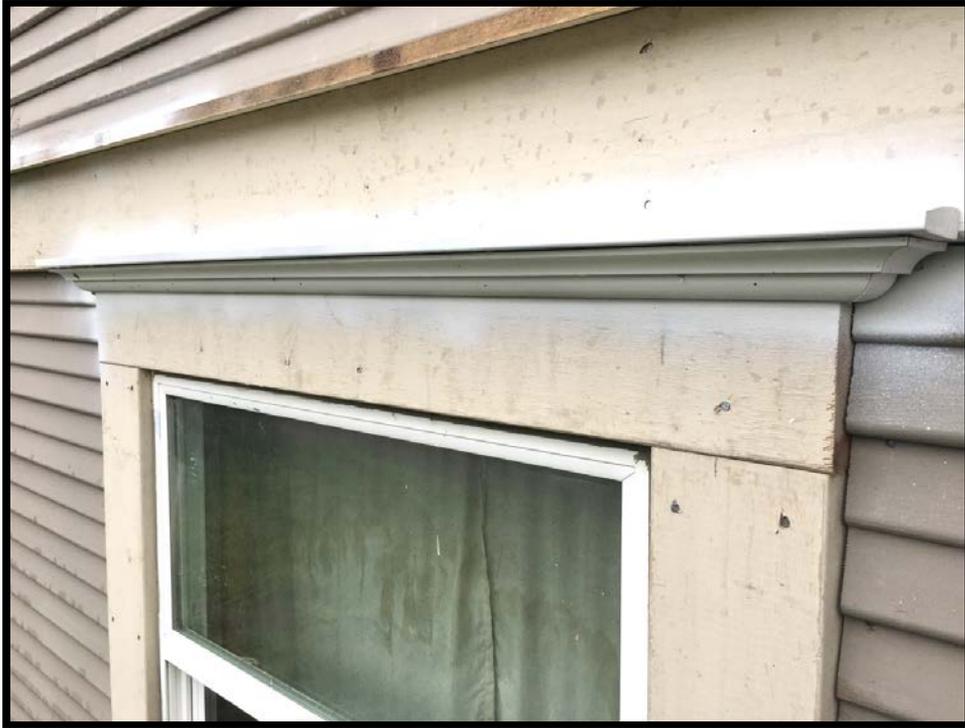
(19) A Closer Look of TRIM and MOLDING detail matching the ORIGINAL Structure of 1910

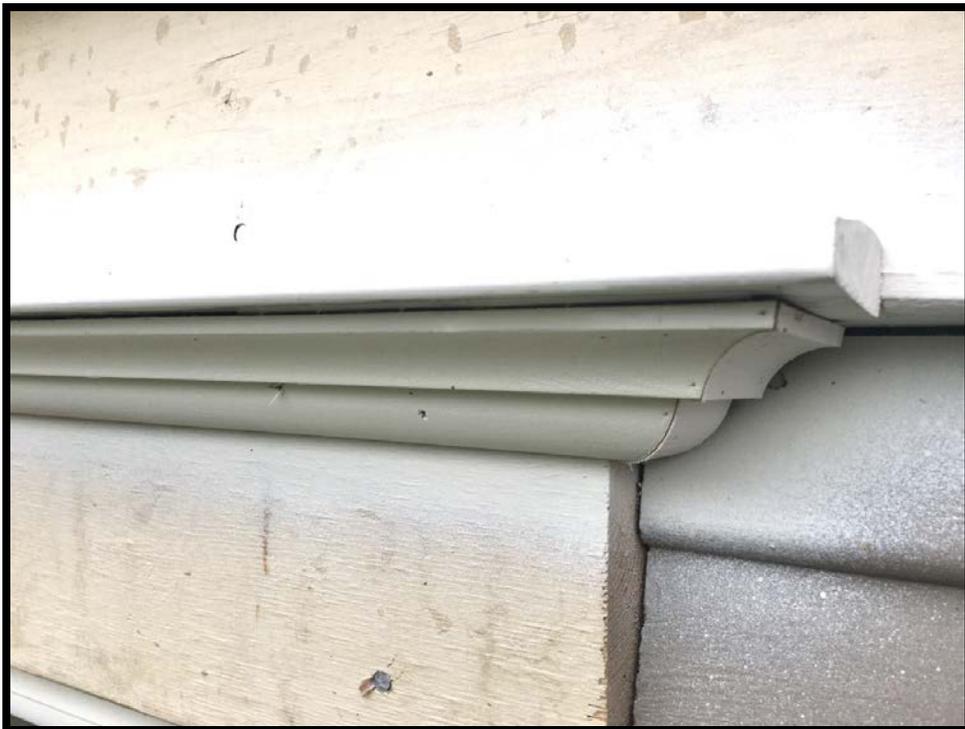
(20) A Closer Look of TRIM and MOLDING detail matching the ORIGINAL Structure of 1910

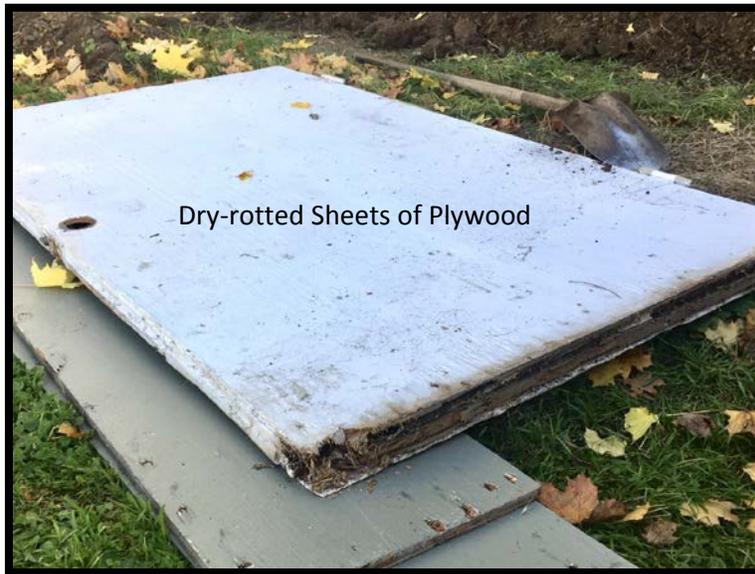
Lastly, the existing door to the lower basement was insufficient and poorly framed, consisted of dry-rotted layers of plain plywood sheets due to its unconventional opening size of 42" wide x 72" tall. We had searched continuously for three months throughout the valley until we found an adequate SOLID WOOD door matching the opening dimensions. With an additional modification, we were able to replace said dry-rotted plywood sheets with a nice wooden lockable door, as shown on pictured item #21 below.

(21) The UNCONVENTIONAL Previous Door to the BASEMENT, consisted of dry-rotted sheets of PLYWOOD

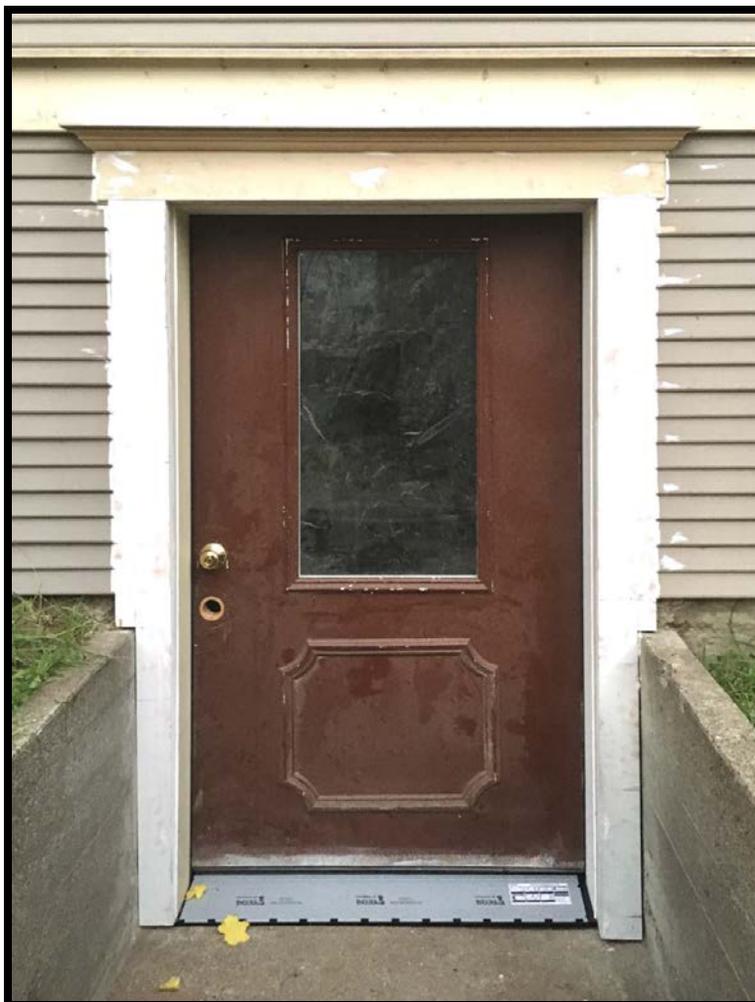
(22) The NEWLY Installed Solid-WOODEN Door for the BASEMENT as referenced in the Property & Project Information hereinabove

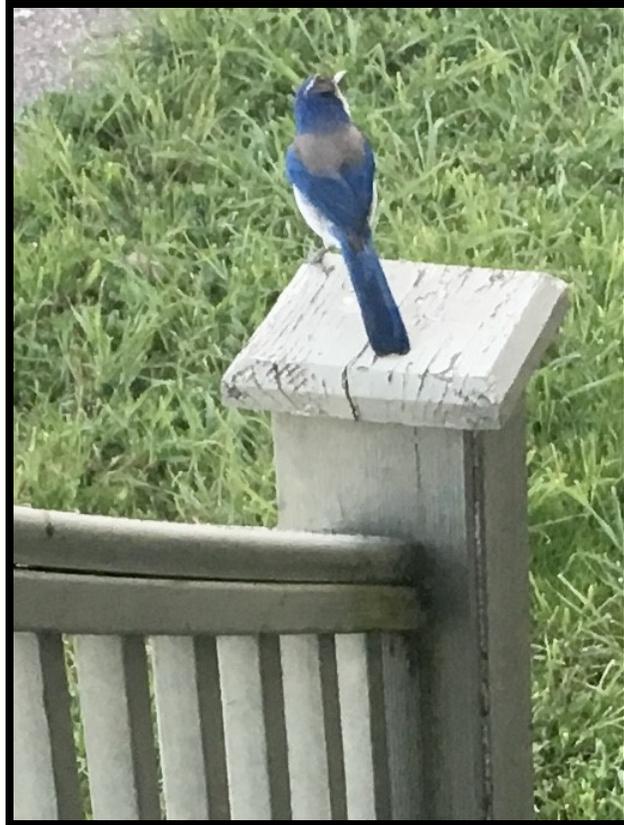
The Original EXISTING POST for the FRONT Staircase on the SOUTH Side

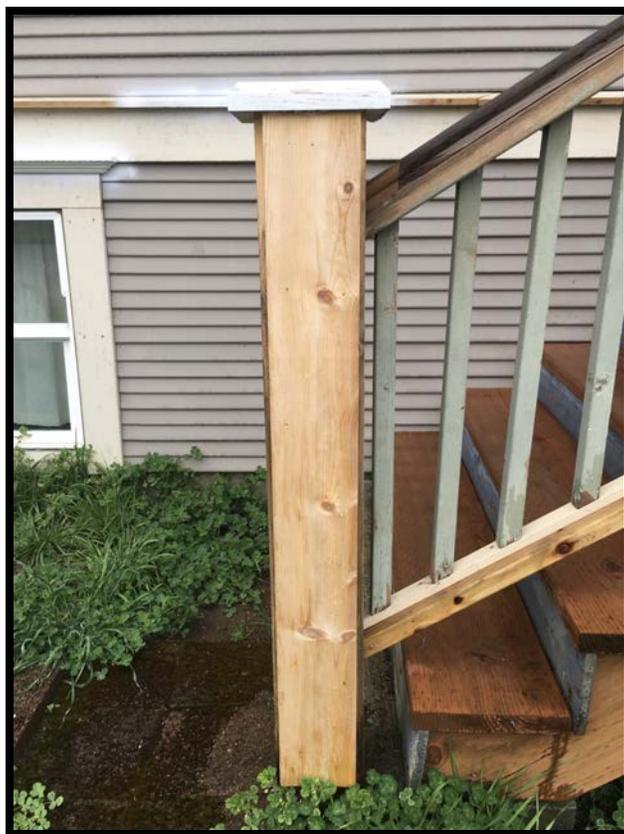
(23) The Newly WRAPPED Post for the FRONT Staircase on the SOUTH Side

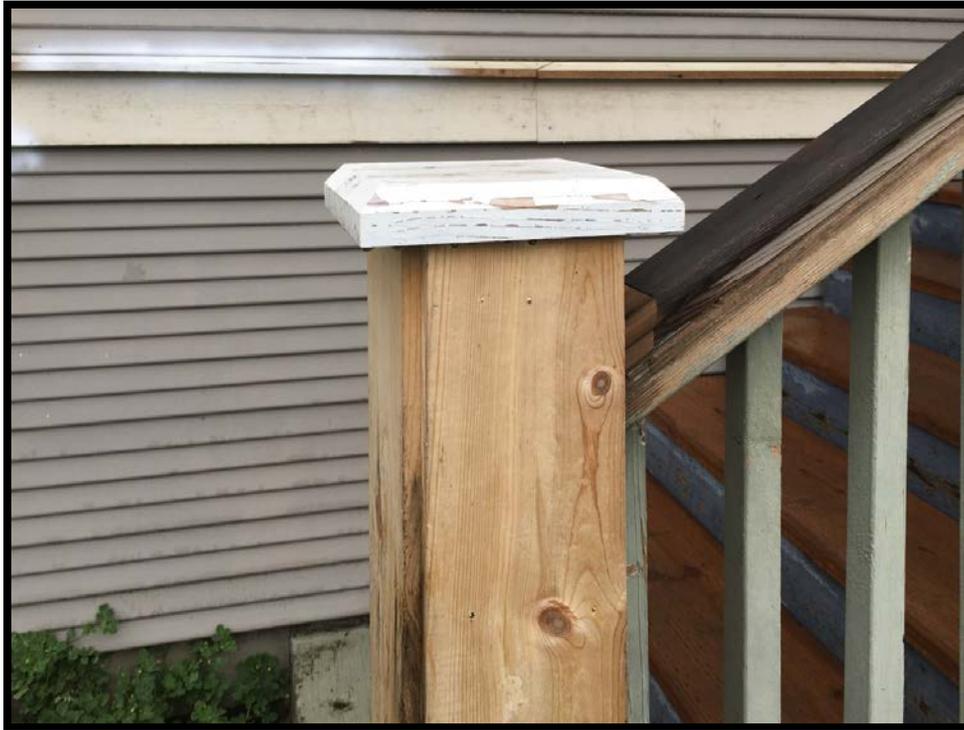
(24) A Closer Look of the FRONT Staircase POST on the SOUTH Side

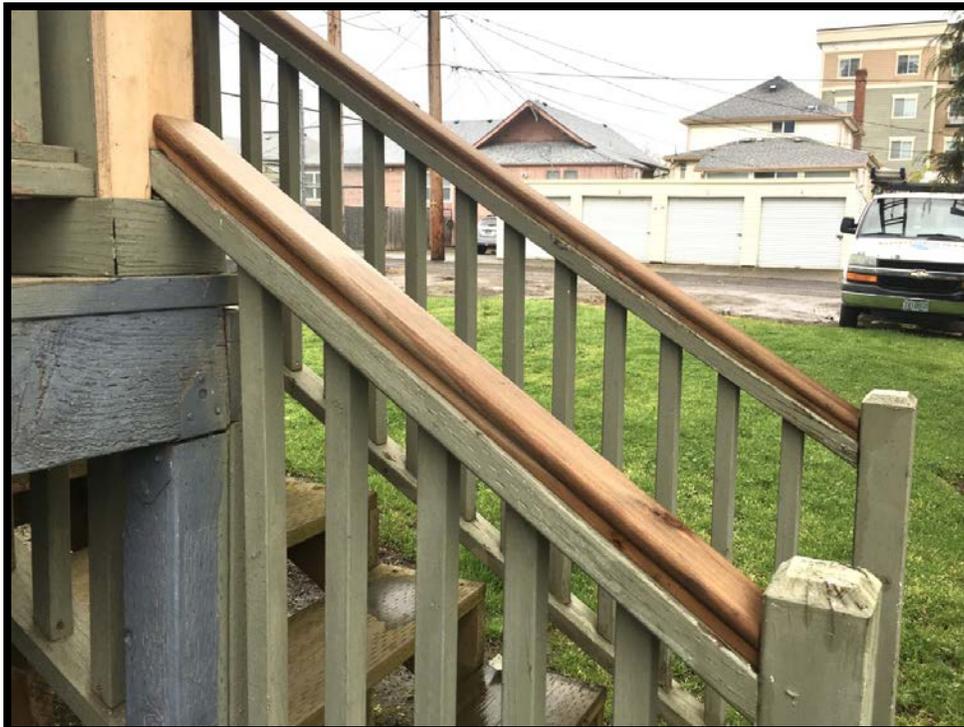
(25) Matching the BACK Staircase Railing (on the North Side of the property) to the Ones on the FRONT (South) Side
